# A Comprehensive Analysis of Wind Turbine Blade Damage

**Abstract:** The scope of this article is to review the potential causes that can lead to wind turbine blade failures, assess their significance to a turbine's performance and secure operation and summarize the techniques proposed to prevent these failures and eliminate their consequences. Damage to wind turbine blades can be induced by lightning, fatigue loads, accumulation of icing on the blade surfaces and the exposure of blades to airborne particulates, causing so-called leading edge erosion. The above effects can lead to damage ranging from minor outer surface erosion to total destruction of the blade. All potential causes of damage to wind turbine blades strongly depend on the surrounding environment and climate conditions. Consequently, the selection of an installation site with favourable conditions is the most effective measure to minimize the possibility of blade damage. Otherwise, several techniques and methods have already been applied or are being developed to prevent blade damage, aiming to reduce damage risk if not able to eliminate it. The combined application of damage prevention strategies with a SCADA syst

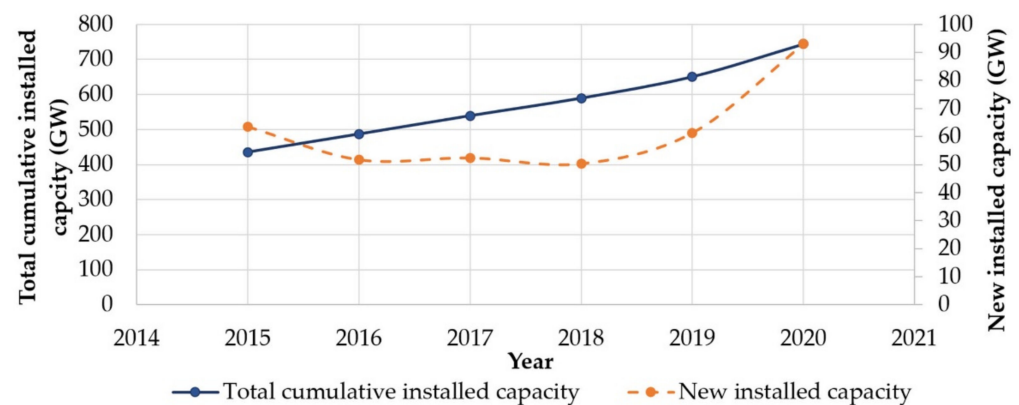
**Figure 1.** Evolution since 2015 in worldwide installed wind park generating capacity [1].

In terms of developed technologies and installed operating facilities for electricity production, wind energy represents one of the leading renewable energy sources (RES)—apart from hydroelectricity, which is an old and widely expanded, mature technology. A total of 744 GW in wind park generating capacity had been installed worldwide as of the end of 2020, of which 93 GW were added during 2020 alone [1]. The evolution since 2015 in worldwide installed wind park generating capacity is depicted in Figure 1.

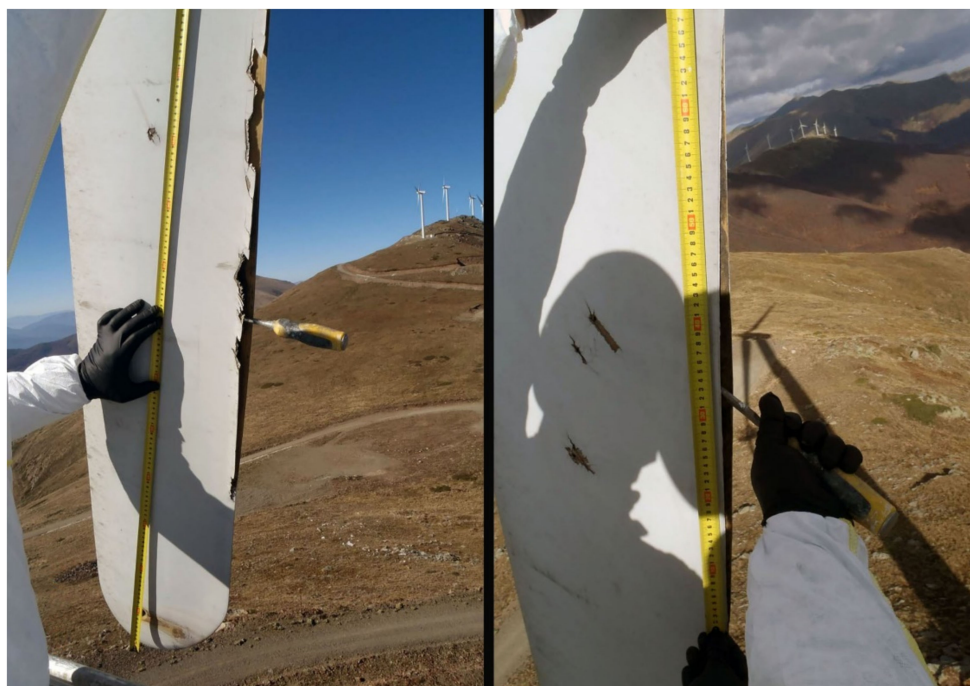
**Figure 5.** Shell debonding of around 1 m length, starting at 40 cm from the blade's tip (**left photo**) and extending 60 cm in length (**right photo**).

**Debonding:** Debonding consists of a localized separation of the upper and lower shells of the blade. It is usually present at the tip or at the trailing edge in the outer few meters of the blade (Figure 5). Usually debonding is caused because the heat generated from the lightning expands the air inside the blade, thus creating internal pressure. The vaporisation of condensed moisture trapped inside the blade can intensify this phenomenon. Debonding is mainly located very close to the tip of the blade, in distances lower than 1 m. However, there can be cases of shell debonding traced in distances up to 6 m from the tip. This is attributed to the fact that the blade is more robust near the hub, and therefore the expansion

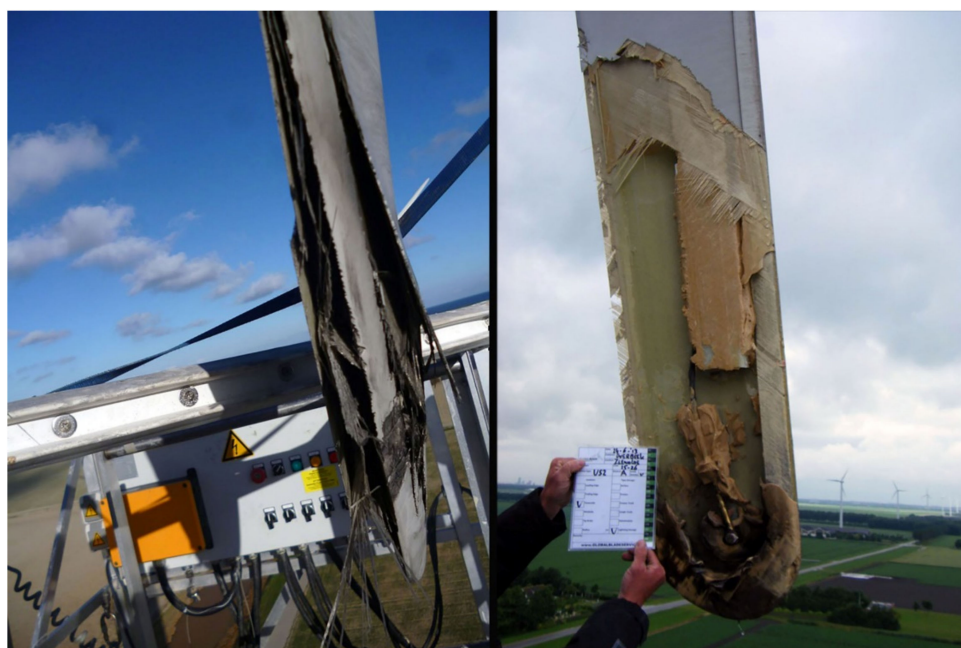
**Figure 6.** Images of wind turbine blade shell detachment.

**Shell detachment:** The shell detachment consists of several meters of one or both shells completely detached from the load carrying structure (Figure 6). Usually, shell detachment starts with shell debonding. The mechanical forces generated by blades' rotation, alongside any flutter induced by the flow characteristics (which change due to the geometry change) and the strong wind gusts during adverse weather conditions, eventually lead to shell detachment. Shell detachment is a rather rare damage caused by lightning strikes on wind turbine blades. In cases of shell detachment, the lightning strike point is usually located within the last 3 m of the blade tip, even if the damage affects several meters of the shell.

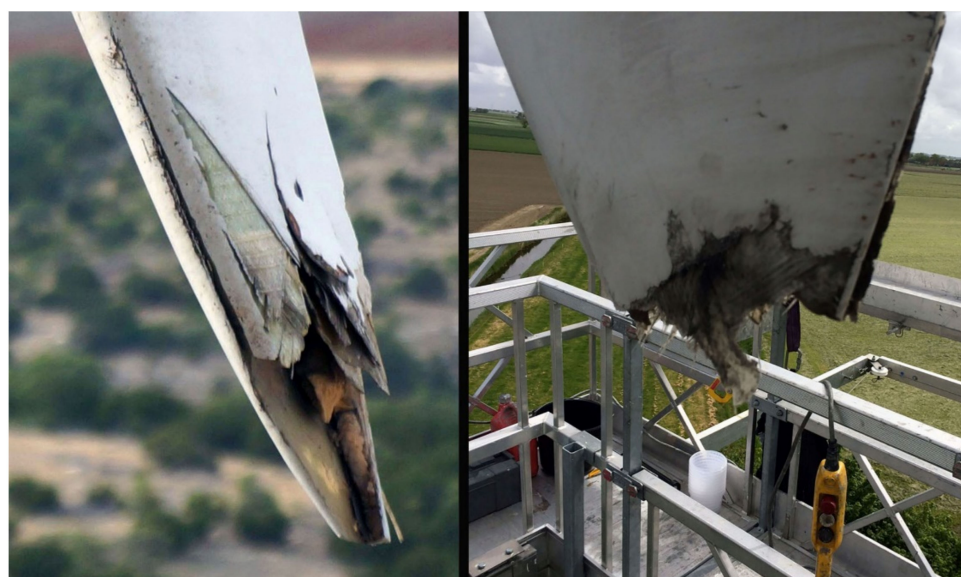
**Figure 7.** Typical images of wind turbine blade tip detachment, caused by lightning strikes.

**Tip detachment:** Tip detachment refers to the complete detachment of several meters of the tip from the rest of the blade (Figure 7). It occurs when the lightning strike severely damages the structural laminate, such that the laminate cannot support the mechanical load and breaks. Consequently, tip detachment can be considered as the most critical case of WTB damage caused by lightning strikes. Tip detachment occurs rarely, most commonly in blades with a carbon fibre structure. For a 20 m blade length, tip detachment is located between 2 m and 7 m from the blade tip (namely, between 10% to 35% of the total blade's length), where a direct lightning strike can be critical for the integrity of the relatively thin laminate of the load carrying structure [38]. This type of damage occurs when the lightning current severely damages the structural laminate, to the extent that the laminate cannot support the mechanical load and breaks [39].

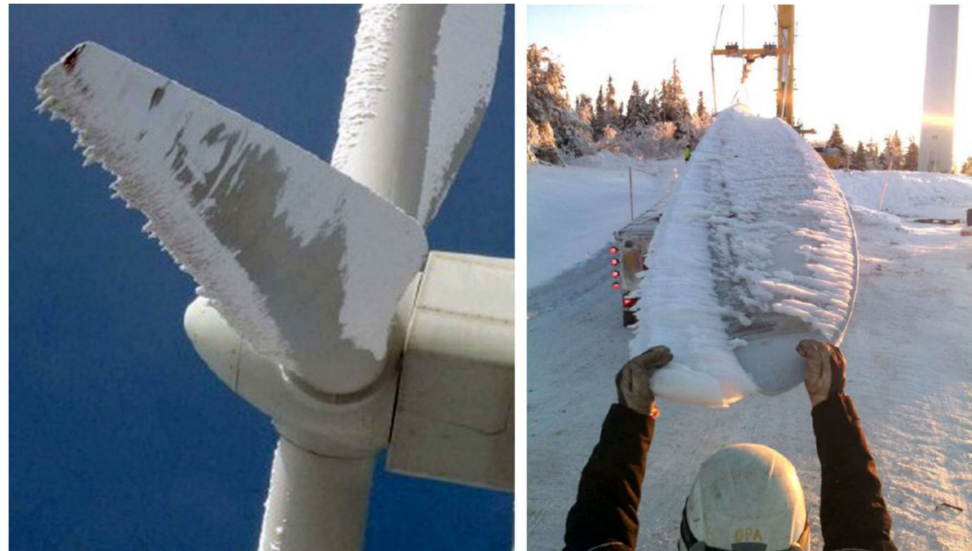
**Figure 13.** Ice on wind turbine blades [69,76].

An example of ice accretion on a turbine blade is presented in Figure 13 [69].

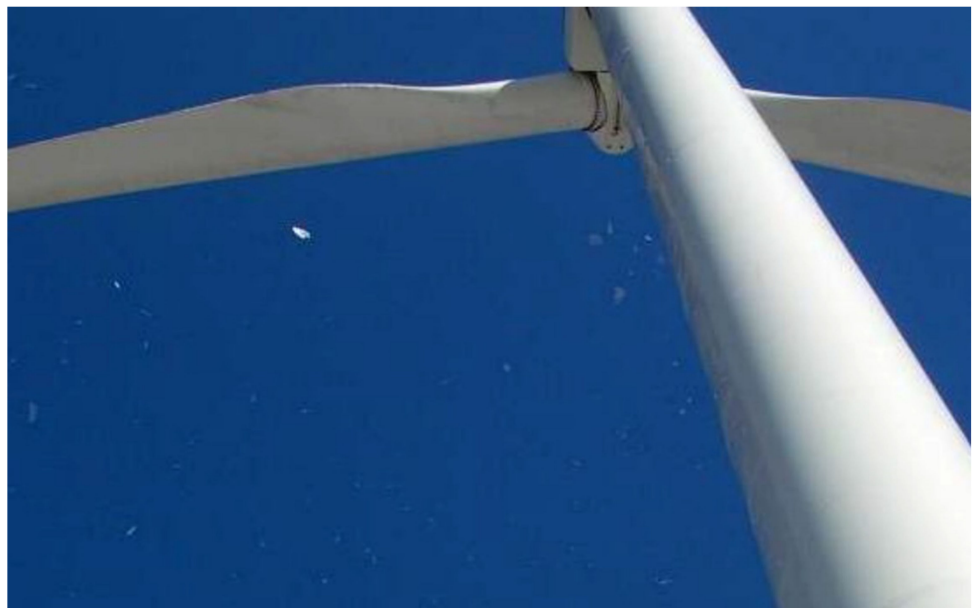
**Figure 14.** Ice falling or being thrown off a wind turbine poses a safety risk to turbine maintenance staff and, depending on turbine siting, the general public [69].

Iced up wind turbines blades and towers can pose a safety risk for wind parks visitors and staff, as large pieces of ice may be thrown from turbine blades during operation. Figure 14 is provided as an example of falling ice fragments [68].

Iced up wind turbine blades and towers can pose a safety risk for wind park visitors and staff, as large pieces of ice may be thrown from the turbine blades during operation. Figure 14 is provided as an example of falling ice fragments [69].
